GULLY MAINTENANCE AND MONITORING TECHNICAL REPORT

Reporting the learnings from the monitoring
and maintenance of gully sites remediated through
the Landholders Driving Change project.

By Bernie Claussen, NQ Dry Tropics

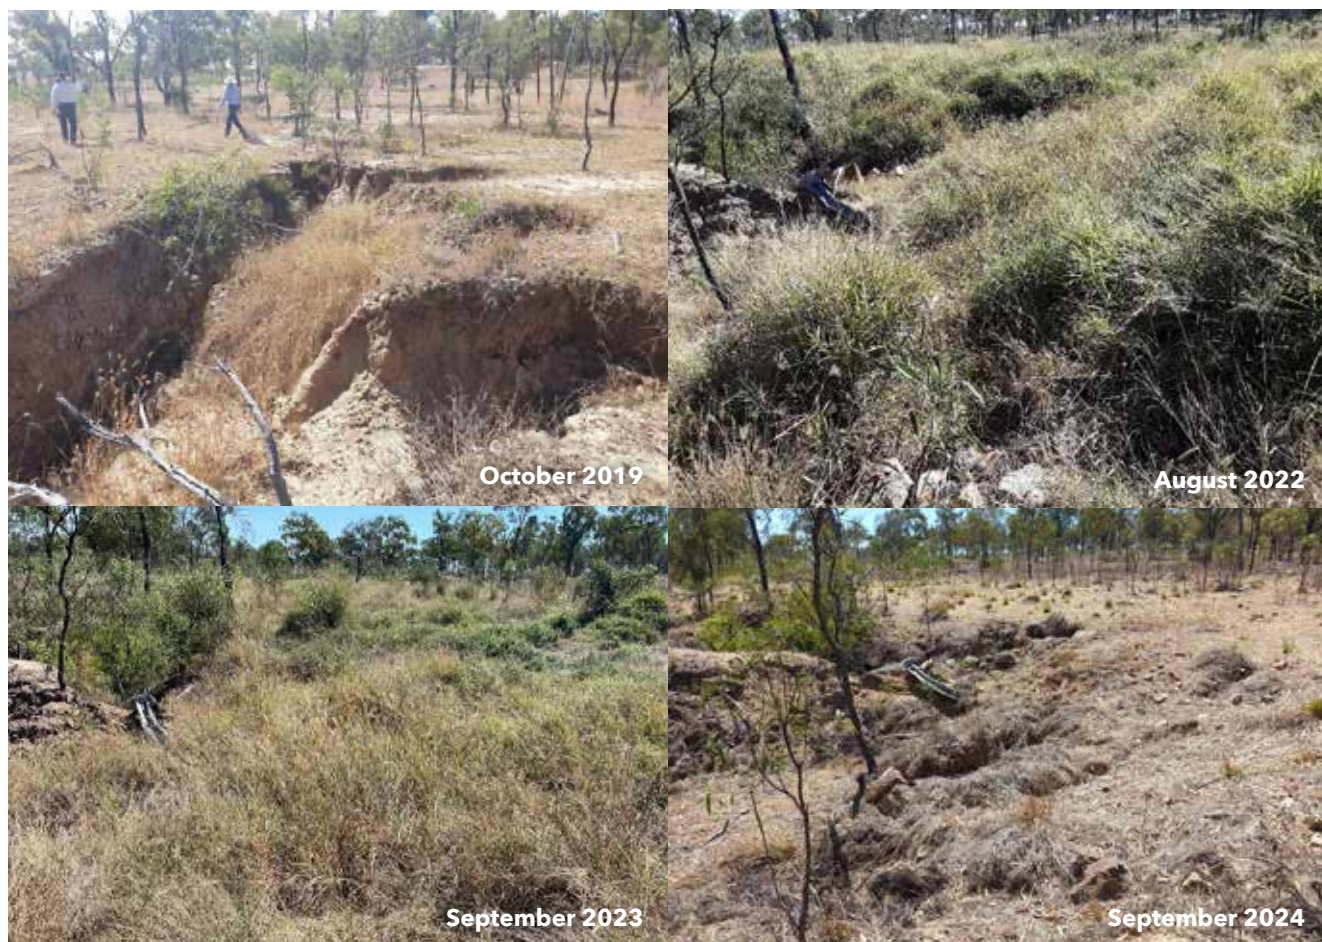
Figure 6. One of the gully heads that was treated by reshaping but with minimal soil disturbance – a rock and soil fill, fertiliser (cow manure) and seeded at Site 20. Note the lack of tussocks after the unplanned graze in 2024. This is discussed in the results section.

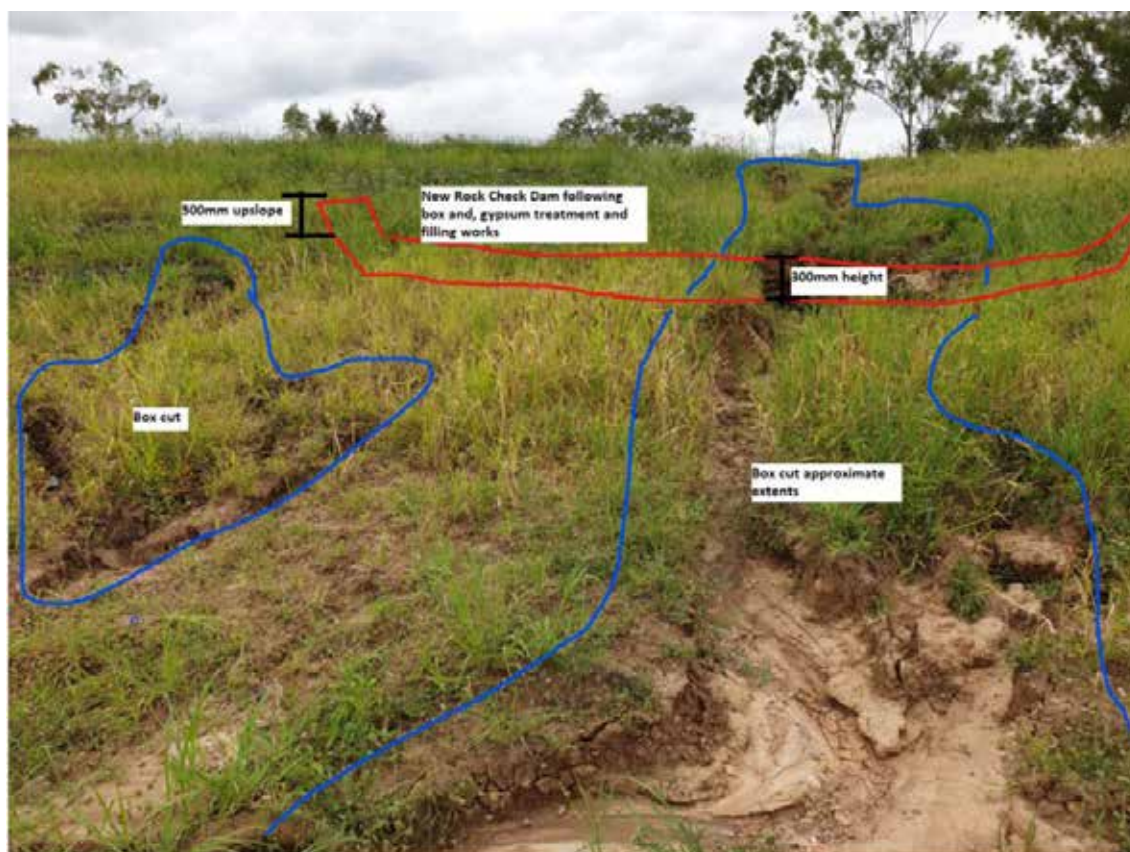
Figure 8. A photograph taken at Site 3 following the 2020-21 wet season. Rills formed during uncontrolled overland flow. The engineer's maintenance plan is overlaid on the photograph. A bund was constructed above the site to prevent this from happening again.

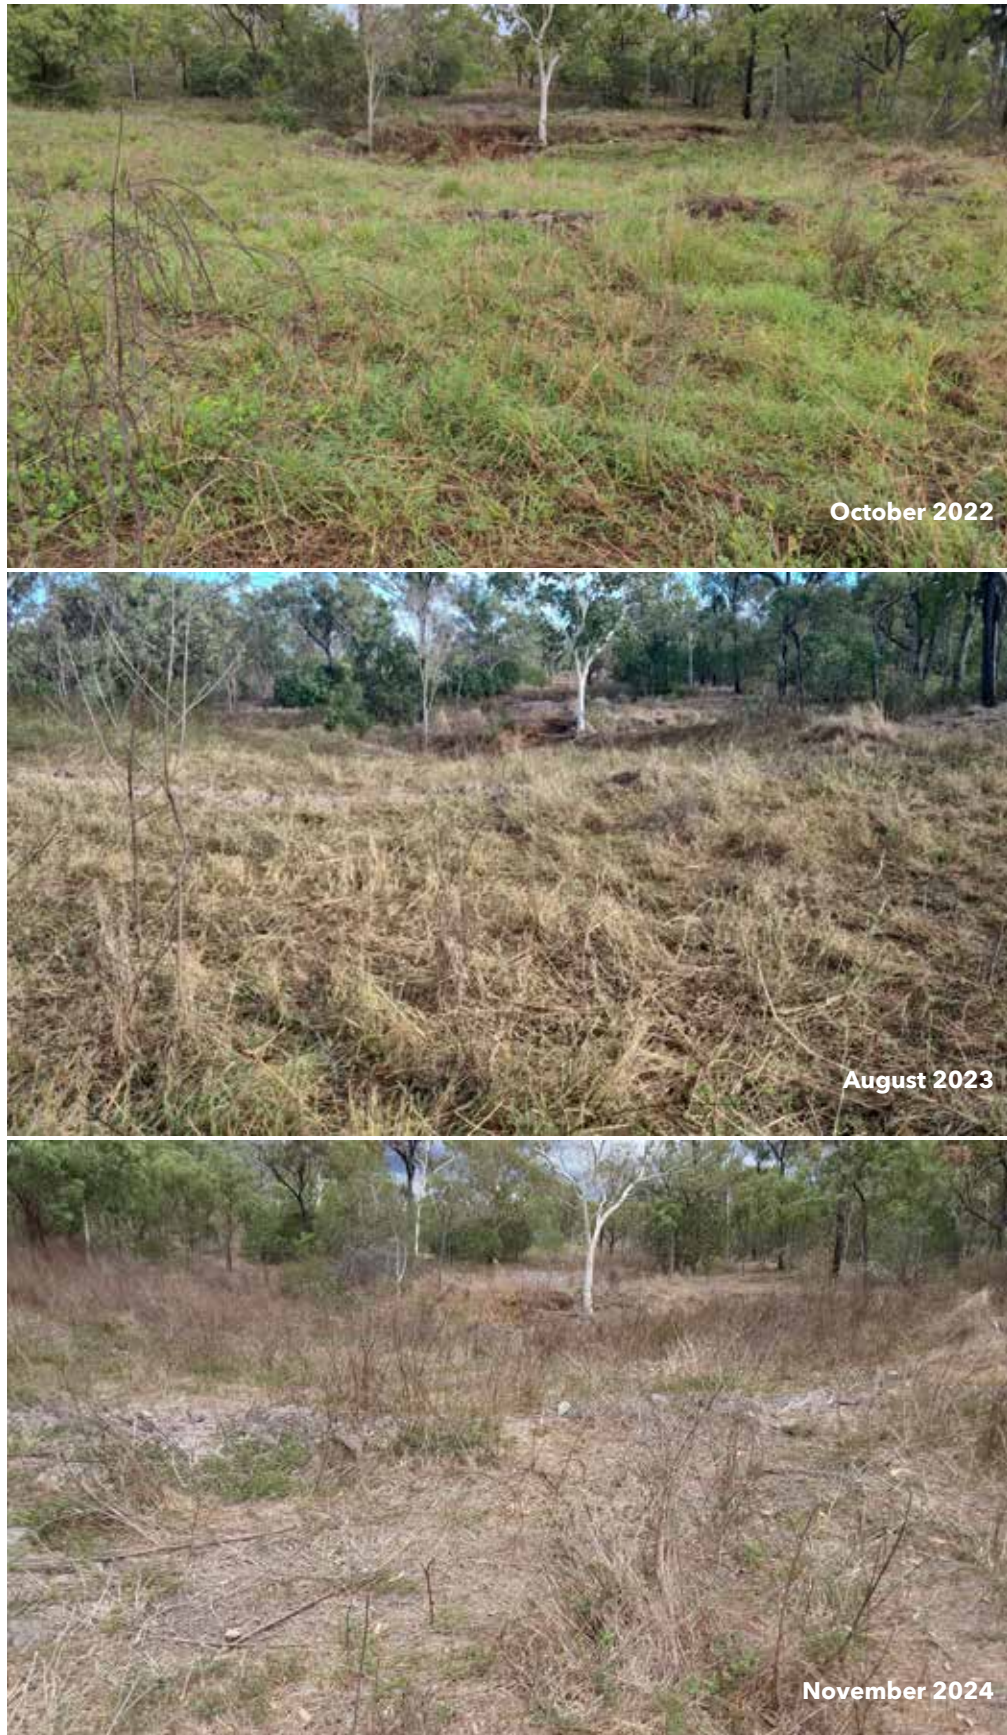
is *Desmanthus*, a palatable hybrid legume. At the control site the dominant pasture was Indian couch, which also reduced the land condition score. Figure 11 shows monitoring photos taken at LCAT 1 site over the three years. These photos are typical of the reshaped, revegetated areas at Site 1 and illustrate the change in dominance from grass to the legume, *Desmanthus "Progardes"* over the monitoring period.

Figure 11. Photographs of Site 1, LCAT 1 over the three years of monitoring; represented in Figure 10 by the blue line. The green pasture vegetation and tall stalks in the 2024 photograph is Desmanthus "Progardes".

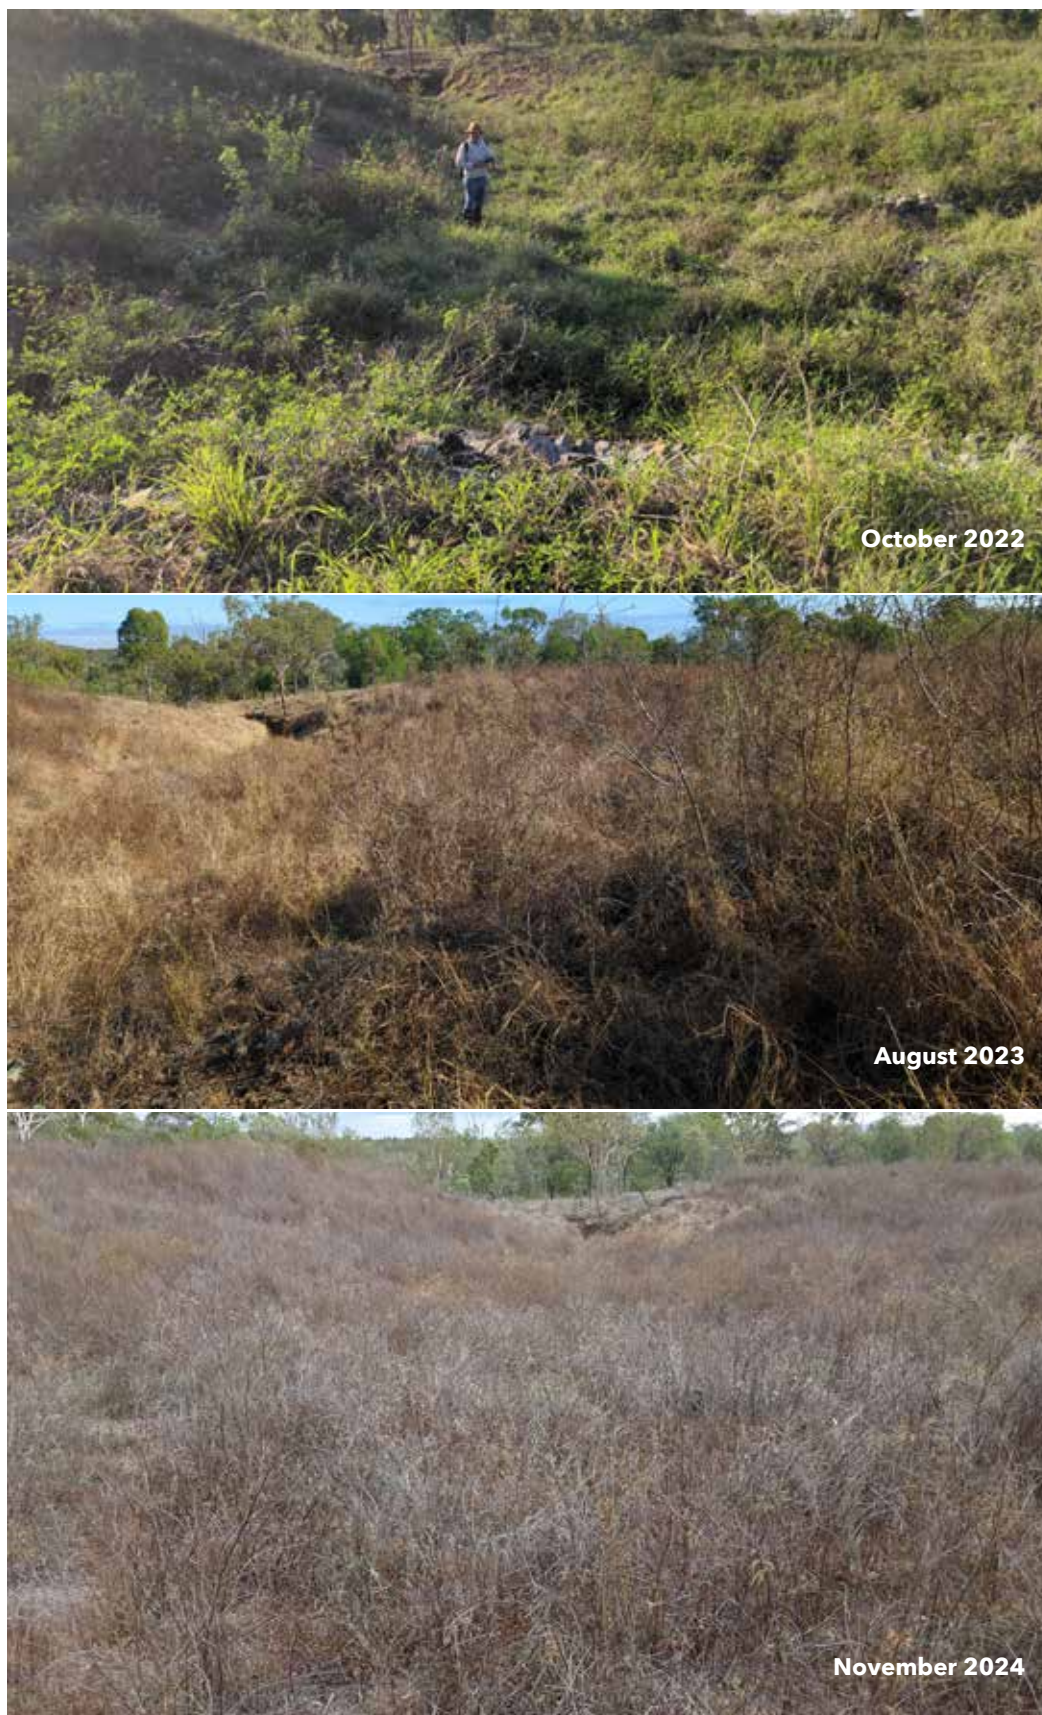
Site 3 and 4 is lower than at Site 2. Like Site 1, the drivers of reduced land condition at Sites 3 and 4 were also 'Soil erosion' and 'Dominant pasture species' *Desmanthus "Progarides"*. Site 2 was in A condition in 2024 and had no drivers of land condition listed.

Figure 13. Photographs of Site 3, LCAT 5 during the three years of monitoring; represented in Figure 12 by the orange line. The decrease in grass and increase in *Desmanthus* “Progardes” is evident in these photographs.

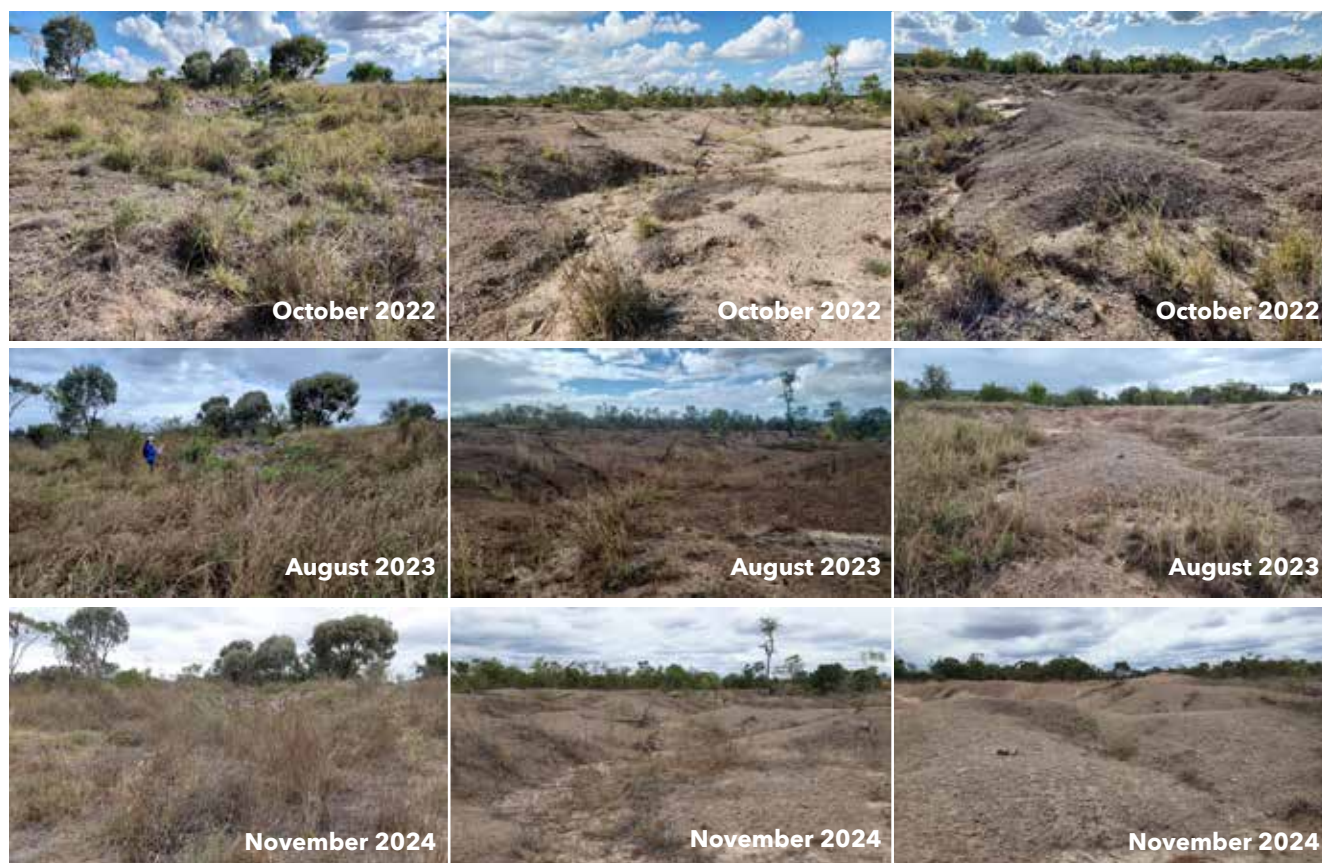
15) is situated at the transition zone between the intense revegetation work in the catchment and on to the rock chute and the 'badlands' that did not receive treatment. In the last set of three photographs in Figure 15 (view north) some of the scarps are visible. In the initial treatment the scarps received some ameliorants without soil disturbance. Some maintenance earthworks were undertaken on some of the scarps that continued to erode.

Figure 15. Site 5 - Series of photographs taken at LCAT 4 site (below the rock chute) represented by the line that is **this colour** in Figure 14.

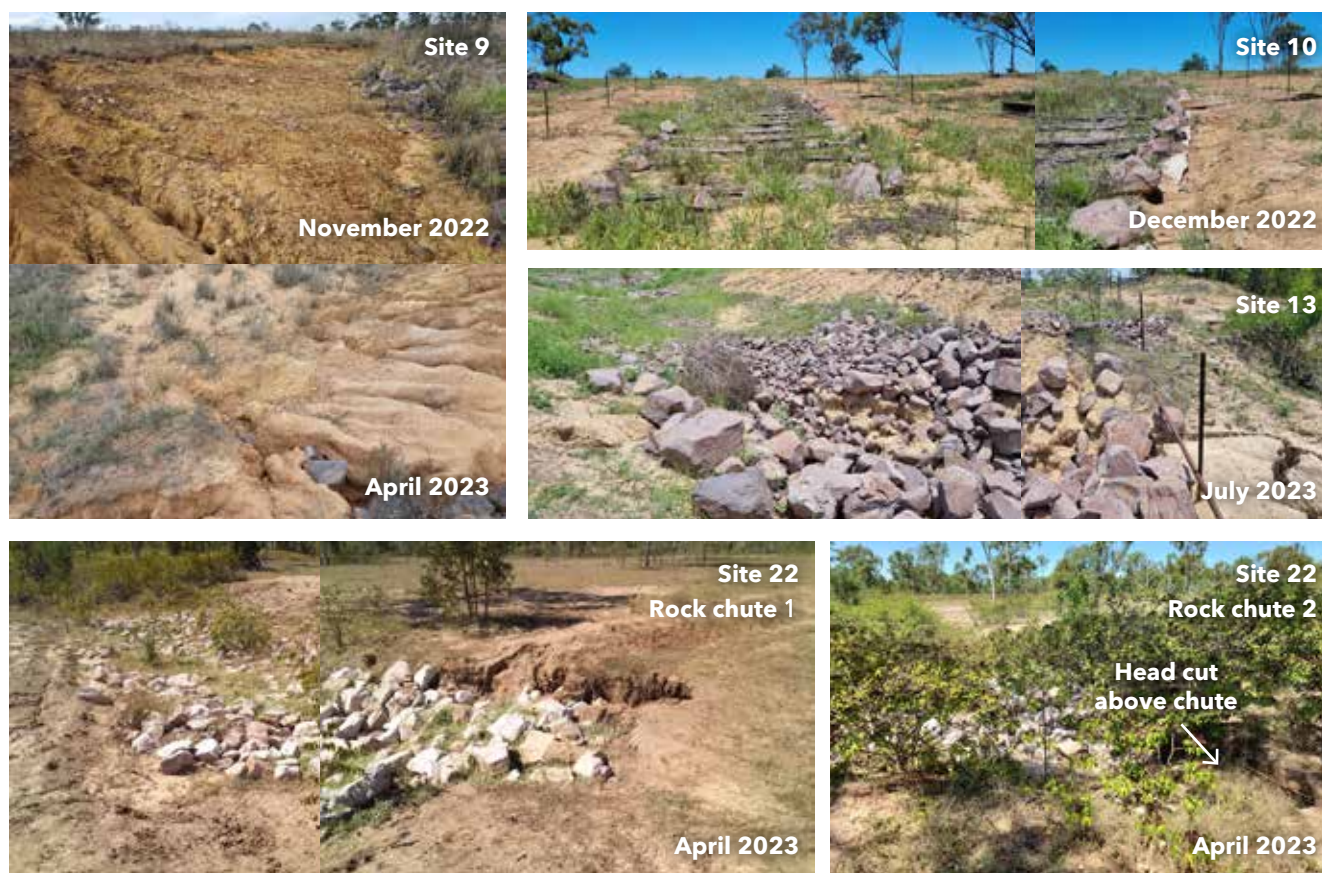
Figure 17. The five rock chutes at small-scale sites on highly erodible Sodosol soils. All have active erosion that will require continued maintenance to be effective.

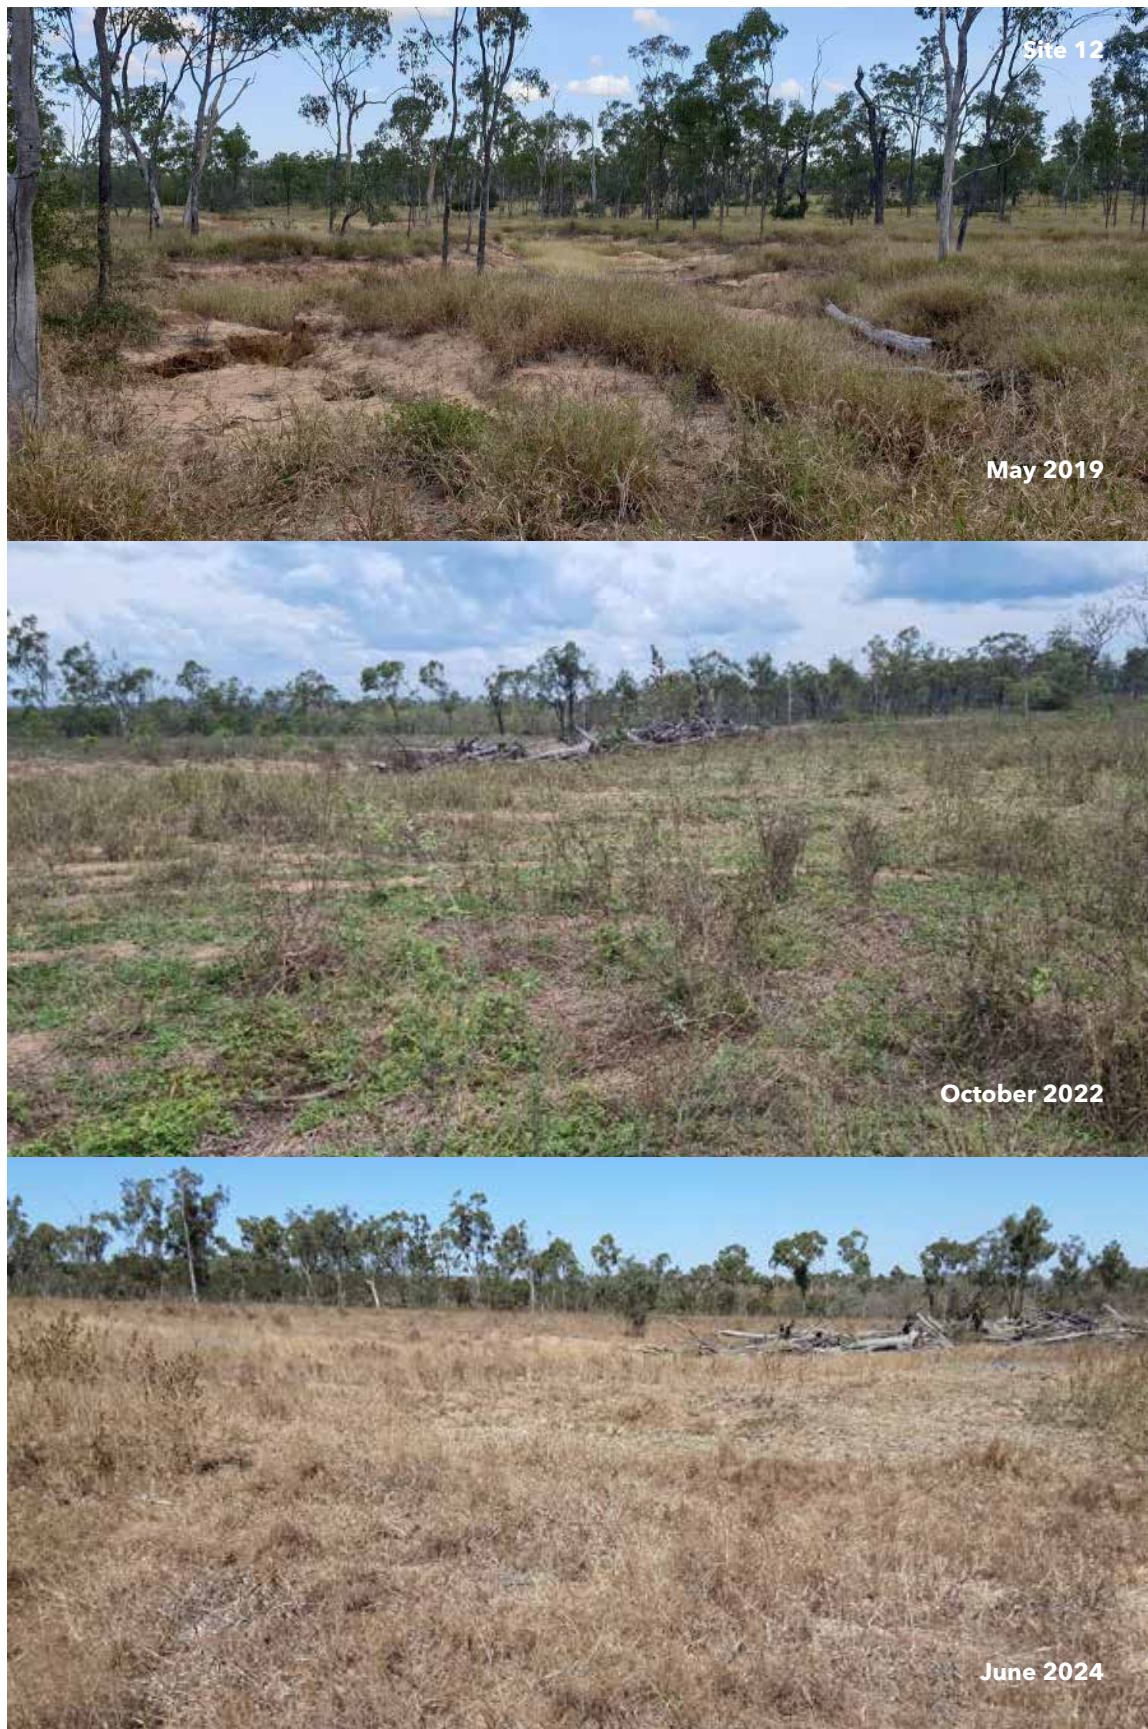
Figure 26. Site 12 was remediated in 2020.

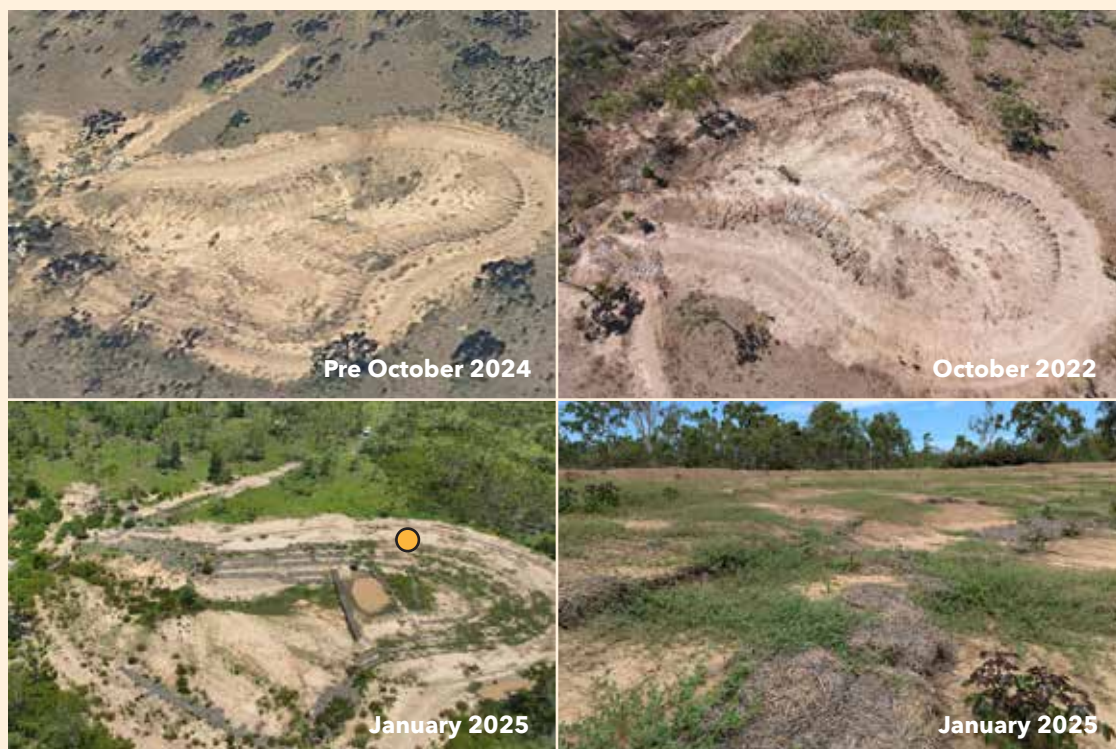
Site 22 underwent maintenance work in October 2024. After lowering the height of the bund and addressing the rill erosion in the reshaped bowl, mulch was placed in berms on the contour. Large square bales were used. The mulch was placed as biscuits (~10 cm thick). As an experiment, the mulch lines in the leading third of the gully (right side in Figure 29) was partially covered with some local soil (topsoil and subsoil mix). A tropical pasture seed mix was hand sown over all disturbed areas. In January 2025, 16 weeks after the maintenance work pioneering forbs, particularly Tar vine (*Boerhavia erecta*), was covering a significant part of the treated area where soil had been placed on the mulch. Unfortunately, Bellyache bush had also germinated rapidly. The sown seed had not germinated yet. The yellow dot in the bottom left photo indicates position where the bottom right photo was taken, facing towards the gully head.

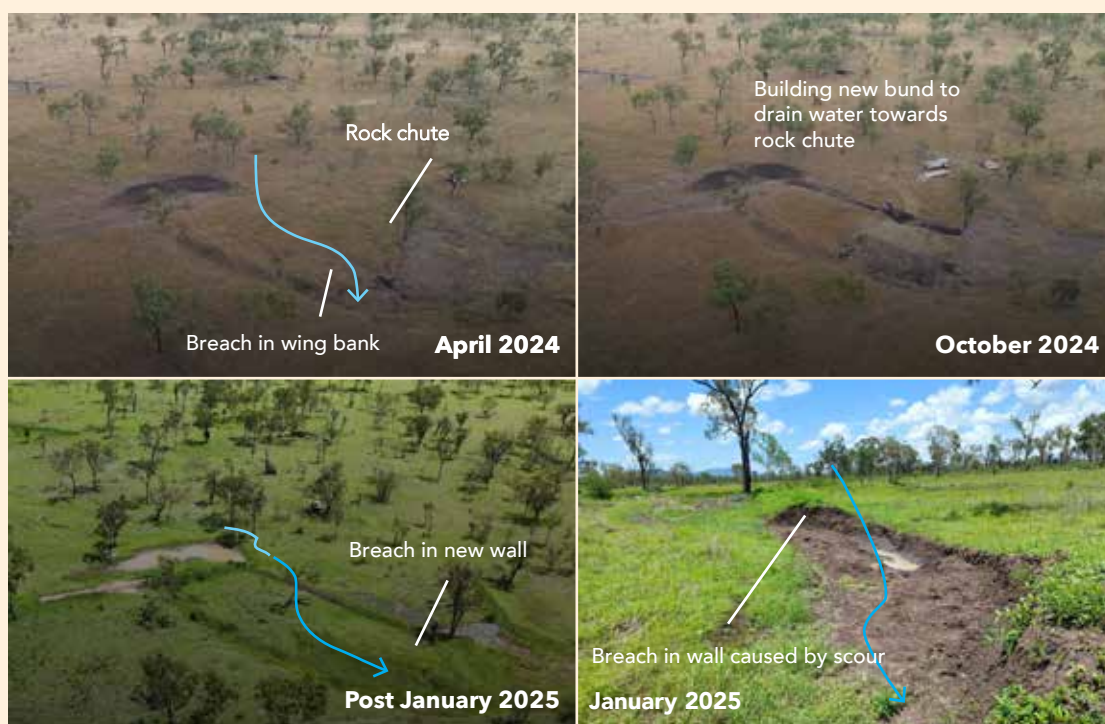
Site 24 - Lessons from a rock chute installation

particularly during intense first rains before the soil has swelled to full water-holding capacity. In addition, this cracking clay, unlike the Vertisols of Brigalow country, is friable, crumbles easily and is vulnerable to all forms of erosion. This was illustrated at Site 24 (see Figure 31).

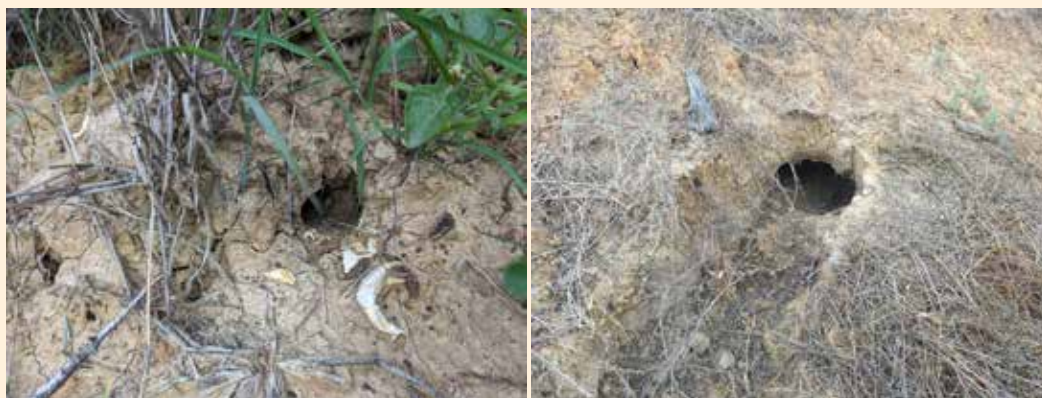
An inland freshwater crab species, likely *Austrothelphusa transversa*, was found at Sites 10 and 24 near earthen walls that had held water but failed during the wet season due to tunnel erosion. While not conclusive, there is a reasonable possibility that crab burrows contributed to these failures, particularly at Site 10, where the soil is sodic (Sodosol).

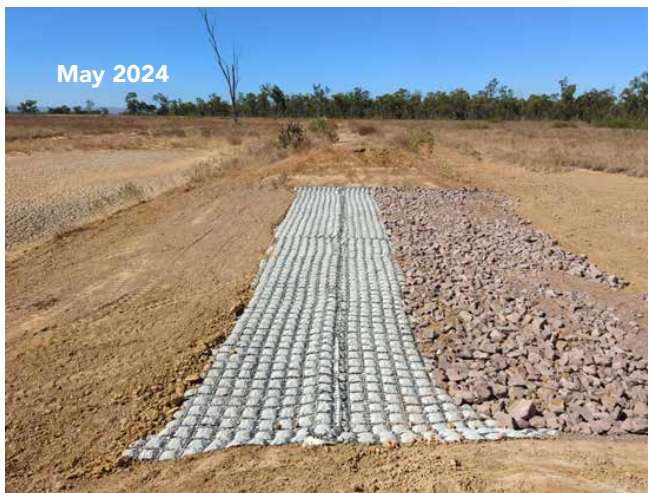
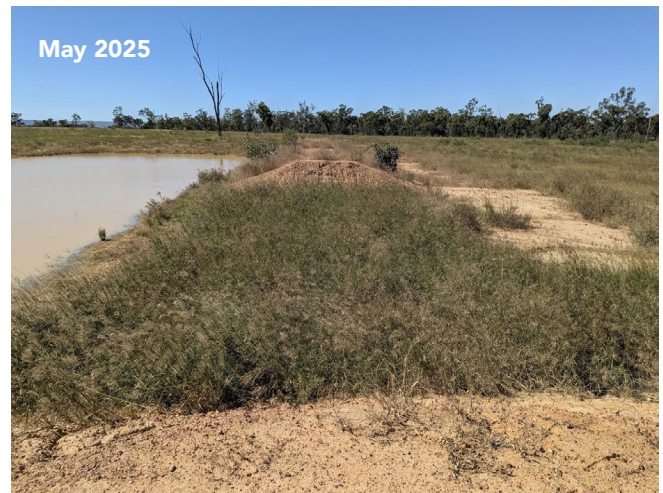
Figure 33. Concrete matting was placed at Site 10 as a trial. Here it was placed at the crest of a spillway.
