GULLY MAINTENANCE AND MONITORING TECHNICAL REPORT

Reporting the learnings from the monitoring
and maintenance of gully sites remediated through
the Landholders Driving Change project.

By Bernie Claussen, NQ Dry Tropics

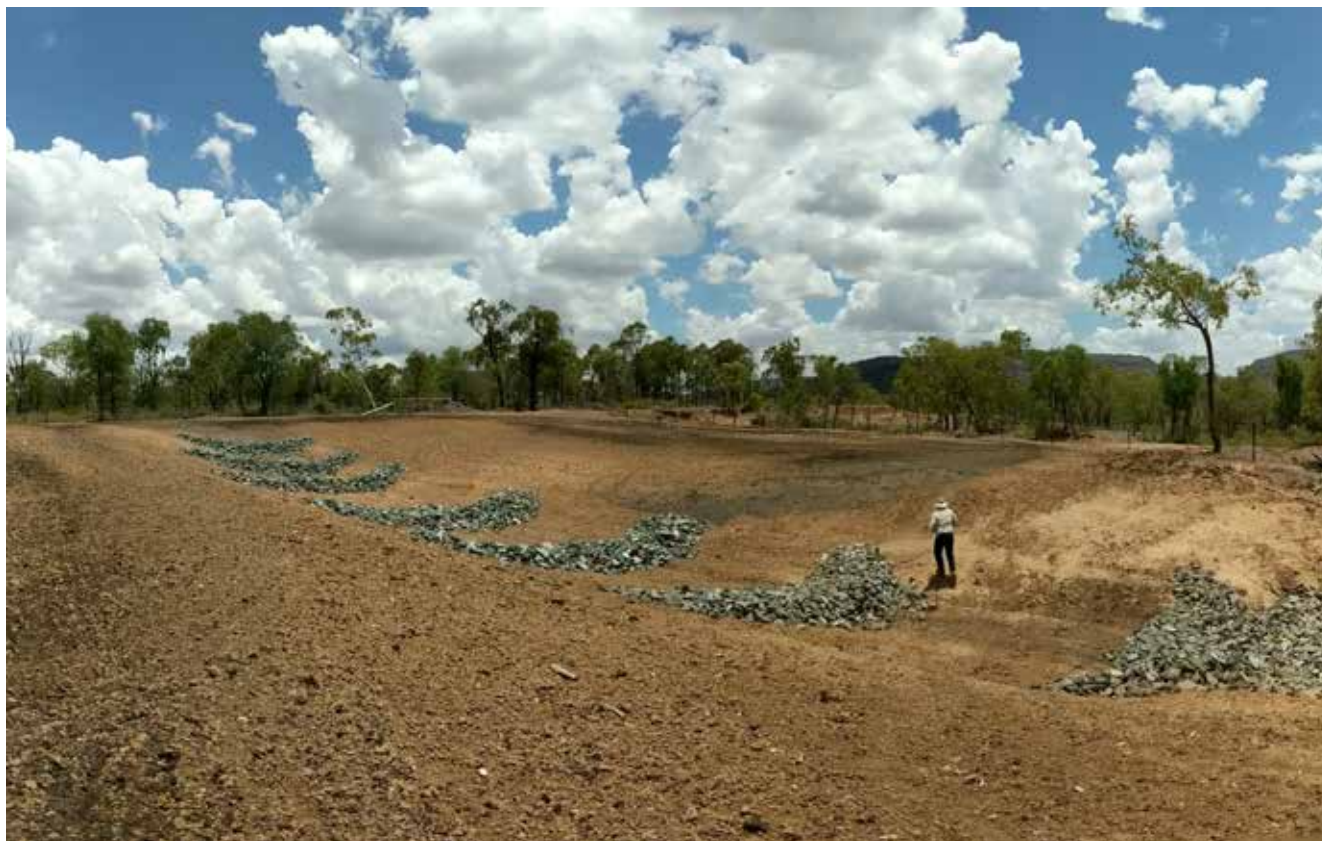
None of the large-scale sites used irrigation or planted woody stems. The many porous check dams installed were constructed of gabion-sized rock and are mostly sited in the channels of reshaped gullies – typically about every 5m (horizontal distance) (refer to Figure 3). The bulk of these check dams are at Sites 2, 3 and 4. These totals include additions during maintenance work: one bund and three rock check dams across three sites.

Figure 3. Porous check dams constructed with gabion-size rock on the large-scale Site 1 following the reshaping, ameliorants, seeding and fencing.

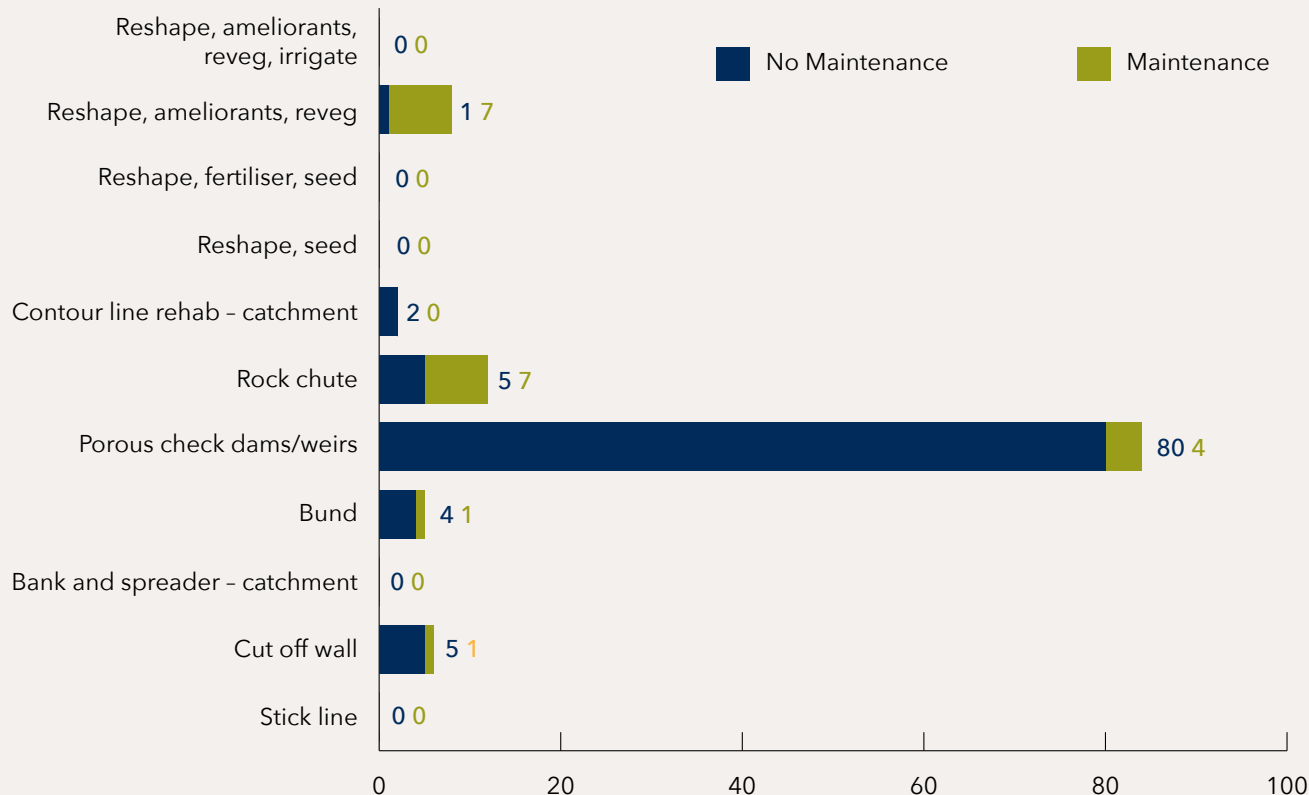
Components of the site works that required and received maintenance were: seven reshaped areas, five rock chutes, four porous check dams, one bund and one cut off wall (Figure 7). The need to repair rills in the reshaped areas was common with seven of the eight areas affected. This damage was mostly caused by direct rainfall on recently reshaped, ameliorated and seeded gully slopes and was most prevalent after the 2021 wet season (Figure 8). Seven of the 12 rock chutes required maintenance, and this involved repairing the earthen abutments or removing tunnels at the edges of the rock chute. Four of the 84 porous check dams required maintenance. This was usually because they had filled, retaining maximum sediment and then outflanked. Like the rills in the reshaped areas, most check dam outflanking happened in the first wet season after construction.

Figure 7. The number of erosion control structures and treatments at large-scale sites that received maintenance compared to those that did not (post-construction up until December 2024).

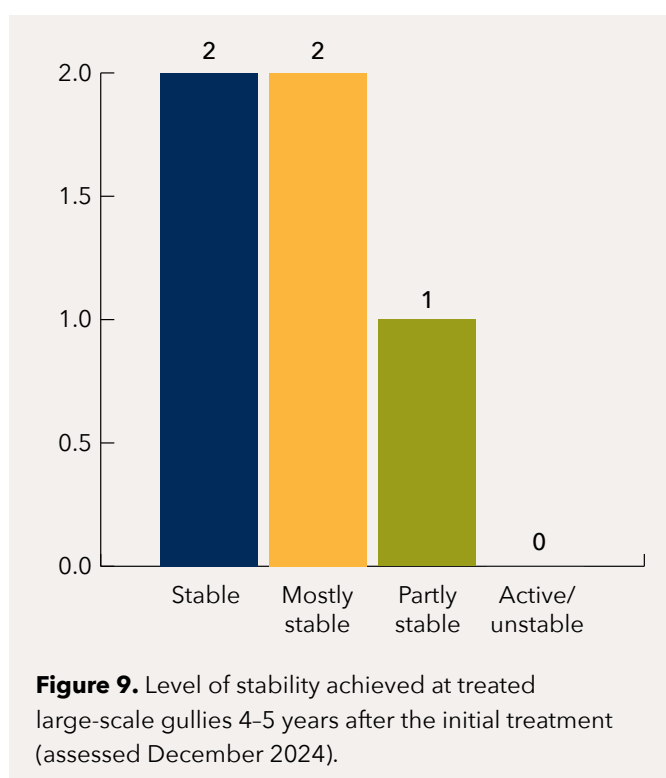
The stability ratings given to the large-scale sites are displayed in Figure 9 and in Table 3. Sites 2 and 3 were given a 'Stable' rating in January 2025, approximately 4½ years after initial works were undertaken. However, this rating comes with a caveat: while these sites are stable for a reshaped landscape; they will not have the stability and associated resilience of comparable intact landscapes with soil profiles that have never been disturbed and with complex, biodiverse vegetation. Furthermore, these sites have not been tested with drought or flood. Sites 1 and 4 were deemed to be 'mostly stable' and Site 5 'partly stable'; the partly stable rating reflects the limited treatment of the extensive 'badlands' together with the success of the revegetation in the immediate catchment.

Figure 9. Level of stability achieved at treated large-scale gullies 4-5 years after the initial treatment (assessed December 2024).

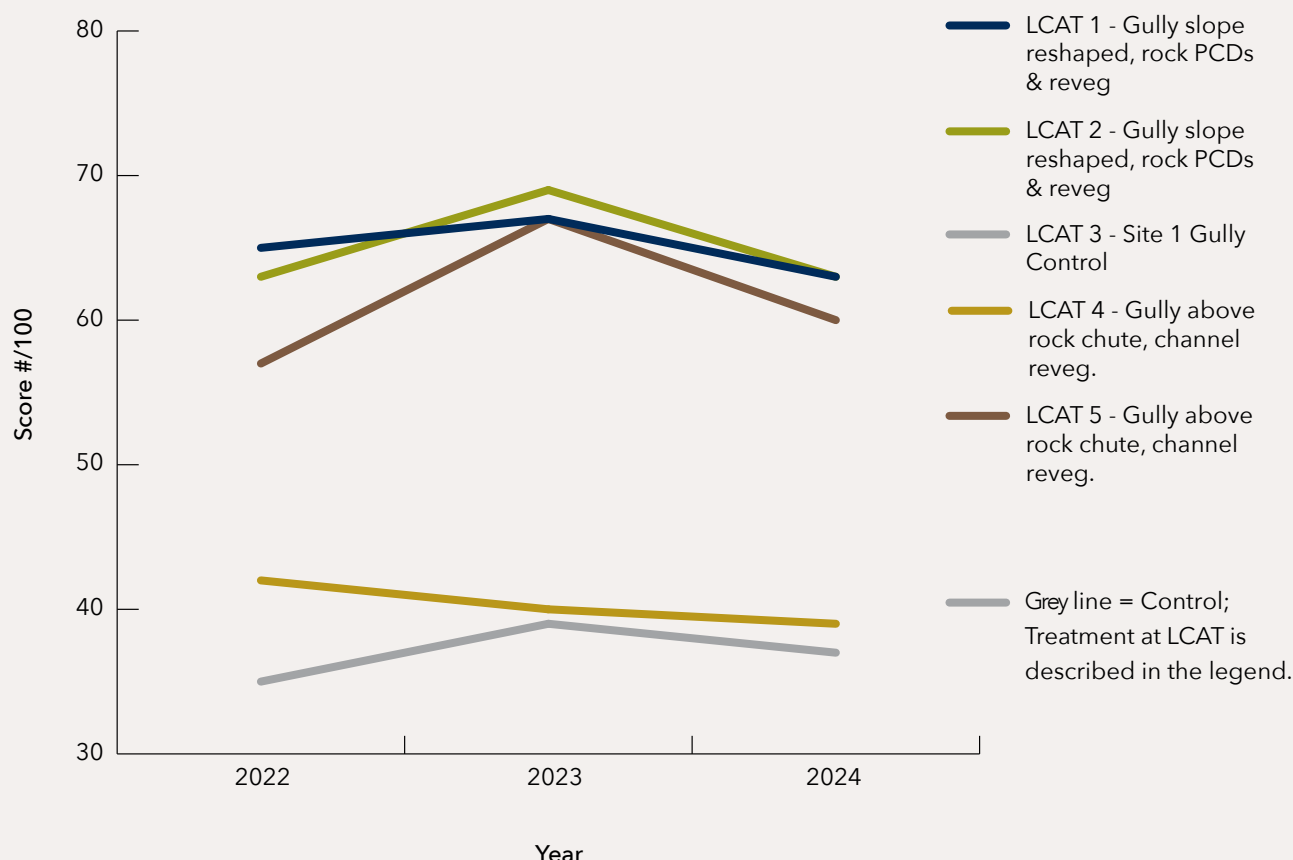
Figure 10. Land Condition scores for large-scale gully remediation Site 1 and its control (untreated gully) over three years of monitoring.

Site 1 LCAT scores have changed little during the three years and all except one hovers around 60/100. However, prior to the treatment in 2020 it can be assumed that the LCAT scores were similar to the control, 35-40. Therefore, the site moved from around 40 to 60 in two years (2020-2022). The drivers of reduced land condition at all sites at the last monitoring (November 2024) was 'Soil erosion' and 'Dominant pasture species' which

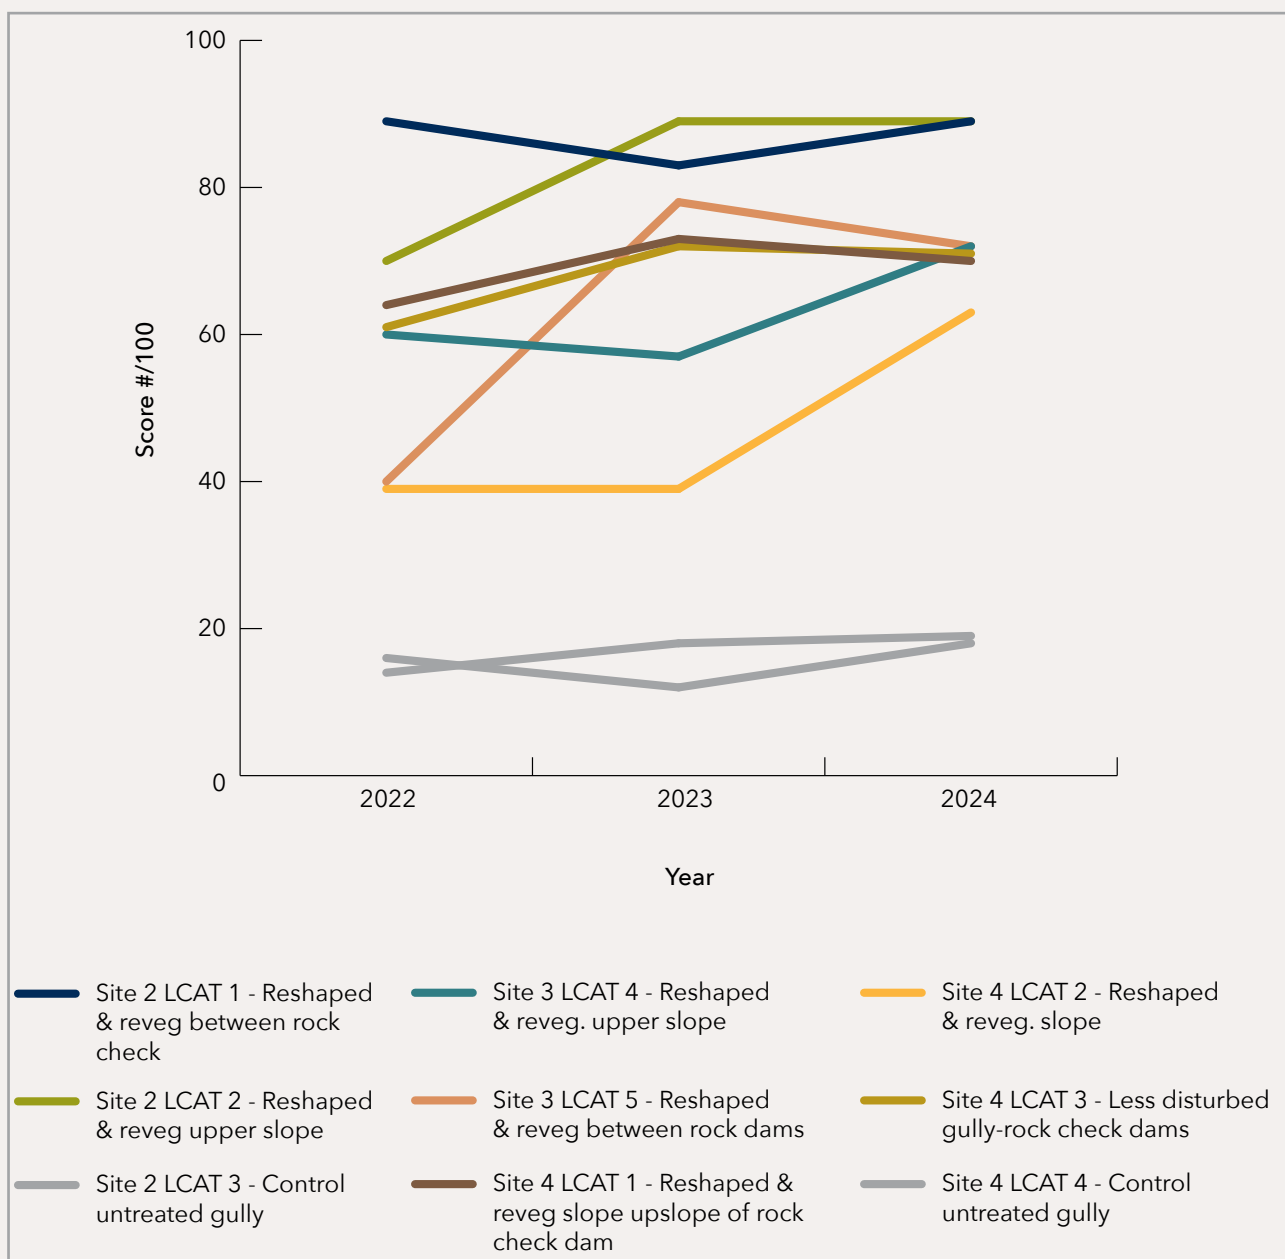
Figure 12. Land condition scores for large-scale gully remediation Sites 2, 3, 4 and control (untreated gully) over three years of monitoring.

Land condition assessment scores at Sites 2, 3 and 4 have generally increased over the three years of monitoring (Figure 12). Site 2 was treated six months earlier than Sites 3 and 4. Scores indicate that it was already in high land condition when the monitoring project began, and that this high land condition has been maintained. Land condition at

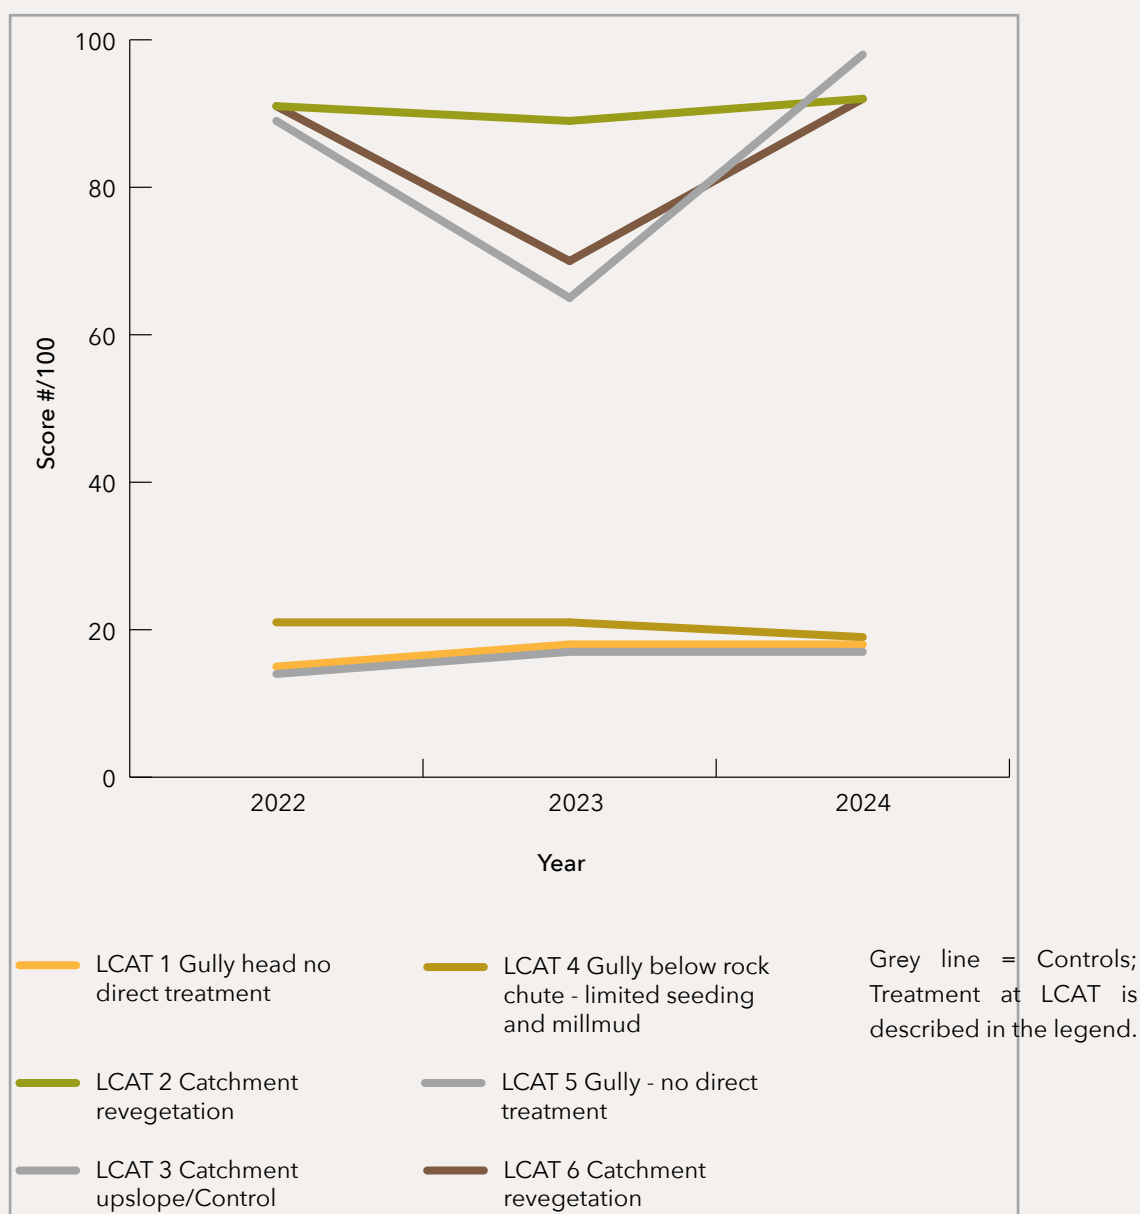
Figure 14. Land Condition Scores for large-scale gully remediation Site 5 over three years of monitoring.

The LCAT scores at Site 5 reflect the success of the revegetation in the catchment contrasted with the limited work in the gullies (Figure 14). As for Site 2, the high results for LCAT 2 in the revegetated catchment indicate that the good land condition was reached prior to the monitoring program. LCAT 3 is in the catchment further upslope away from the gully. The LCAT score for the treated catchment was likely to have been around 50/100 prior to treatment in 2020. Site 5's LCAT 4 (Figure

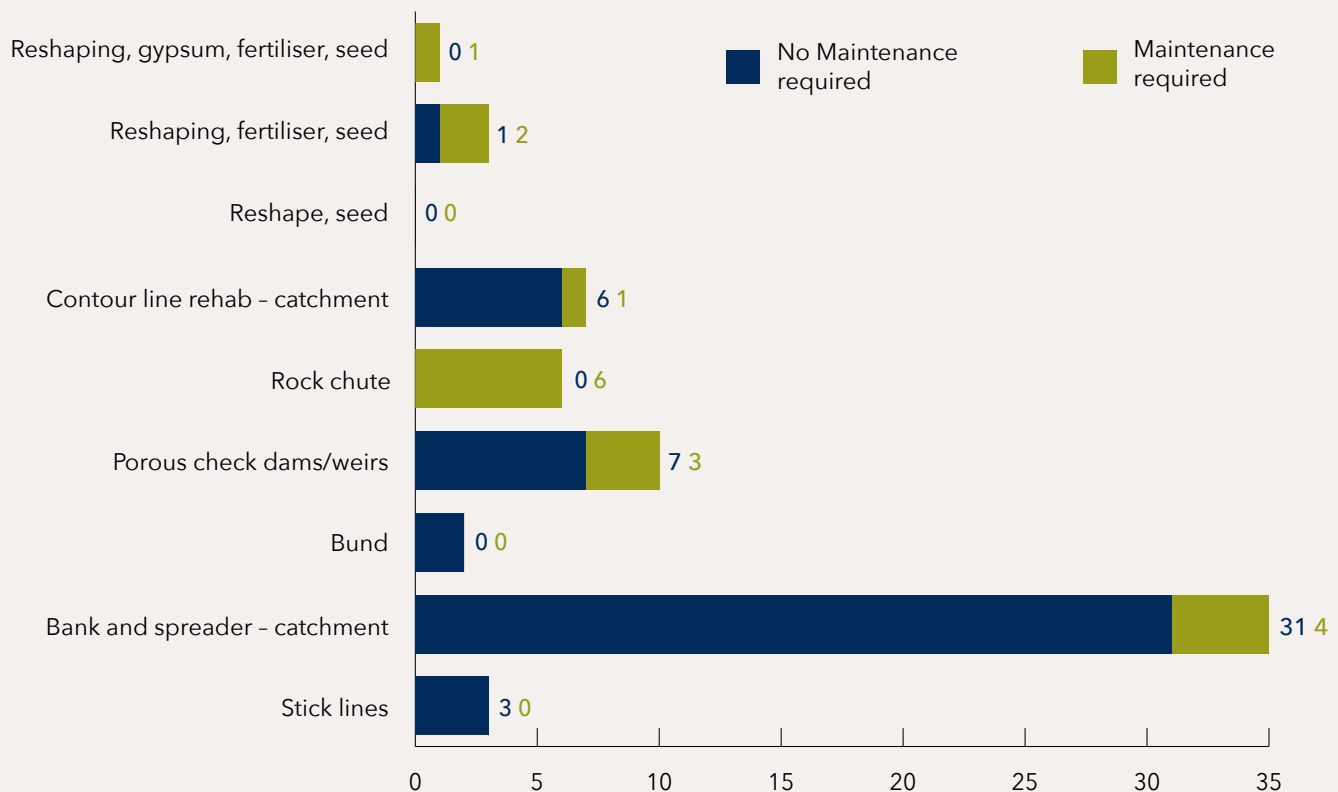
Figure 16. The number of the structures and treatments at the 19 small-scale gully sites that required maintenance compared to those that did not.

Works in the catchment required less maintenance than works in the gullies. One of seven sites with catchment rehabilitation along contour lines required maintenance. This site (Site 19) was not prioritised for maintenance; it is a small site (<0.5ha) in a remote area. In the initial treatment the site was ripped, fertilised and seeded very close to the gully edges; the rehabilitation failed in the area upslope of the gully heads, leading to further, and probably, exacerbated erosion. The rehabilitation was more successful on the treated side of the gully.

Three sites had treatments involving major soil disturbance (reshaping) to the gully itself, followed by soil ameliorants (gypsum and fertiliser or just fertiliser) and seeding. All sites that were highly disturbed required maintenance to address rill erosion. At one site (Site 12) the landholder responded quickly to the rilling that appeared in the first wet season, installing extensive rock and stick check dams (in-kind). The second site (Site 22) was repaired in 2024 and, by this late stage, rilling in the reshaped bowl was deep and starting to form gullies. Site 20, the less disturbed site (gully head fill and manure; Figure 6), seemed to be doing well with high and diverse vegetation cover but now it requires maintenance; during the 2024

dry season cattle breached the exclusion fence and grazed down the area which exposed tunnels at the gully head. The site that is recorded as not receiving maintenance to the reshaping in Figure 16 is Site 13. It has a small area of revegetation on near level ground that is stable, however the maintenance that was required at this site has been recorded under the rock chute category. The two highly disturbed sites that required maintenance were on sloped landforms.

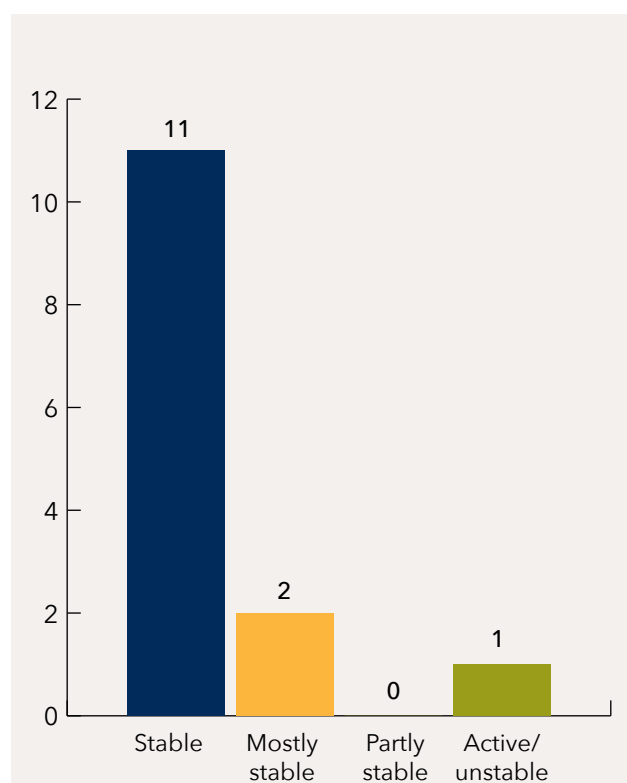
Remediation works in the catchments of gullies had a high level of success. Of the 14 sites, 11 catchments were stable after 4-5 years, two catchments were mostly stable and one was deemed unstable (Figure 18). The unstable catchment is at Site 19; a small site not prioritised for maintenance; described in the maintenance section above.

Figure 18. The level of stability achieved in the treated catchments of small-scale gullies 4-5 years after the initial treatment. Assessed December 2024; sites where only the gully was treated are excluded.

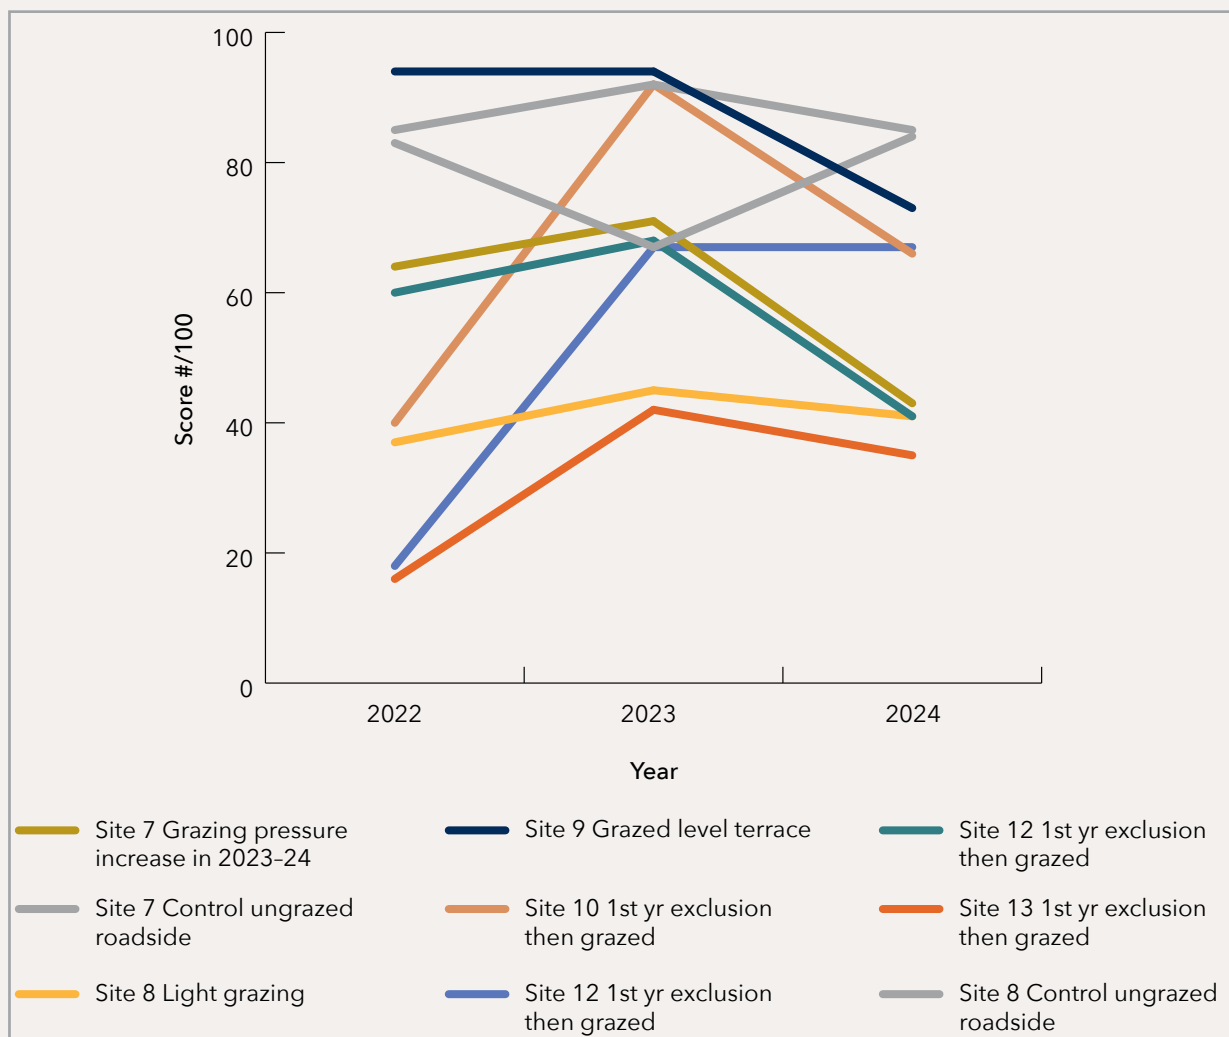
Figure 19 displays three years of LCATs scores from treated catchments with Sodosols; duplex soils with highly erodible subsoil. All these sites are within the Scottville area. Some of the catchments had soils that graded into Chromosols; erodible duplex soils that tend to slake but not disperse. Site 13 is one of these where there was dispersive duplex soil at the gully and the lower parts of the catchment and slaking duplex soil in the higher parts of the catchment. Site 13 is the only site with Sodosol soil that was deemed to be 'mostly stable' (Figure 18). The other five sites represented in Figure 19 achieved a 'stable' rating (Figure 18).

In Figure 19 there are a broad range of LCAT scores with some sites reaching similar conditions to the well vegetated and stable control sites. Land conditions tended to rise and then fall over the three years. Drivers of reduced land condition were similar across the sites: Dominant pasture species, soil erosion and, less commonly, dominant pasture density. Common pasture species are Sabi grass (*Urochloa mosambicensis*), Indian couch (*Bothriochloa pertusa*) and Seca stylo (*Stylosanthes scabra*). These are the dominant species at Site 8 shown in Figure 20. At several sites Seca stylo increased in density during the three years of monitoring while the sown grass species seemed to decline. This was observed at Site 10 (Figure 20). Factors causing this may include a decline in fertility following the initial disturbance and grazing pressure.

Figure 19. Land condition assessment scores for the catchments of small-scale gullies in erodible duplex soils (Sodosols) following pasture renovation works.

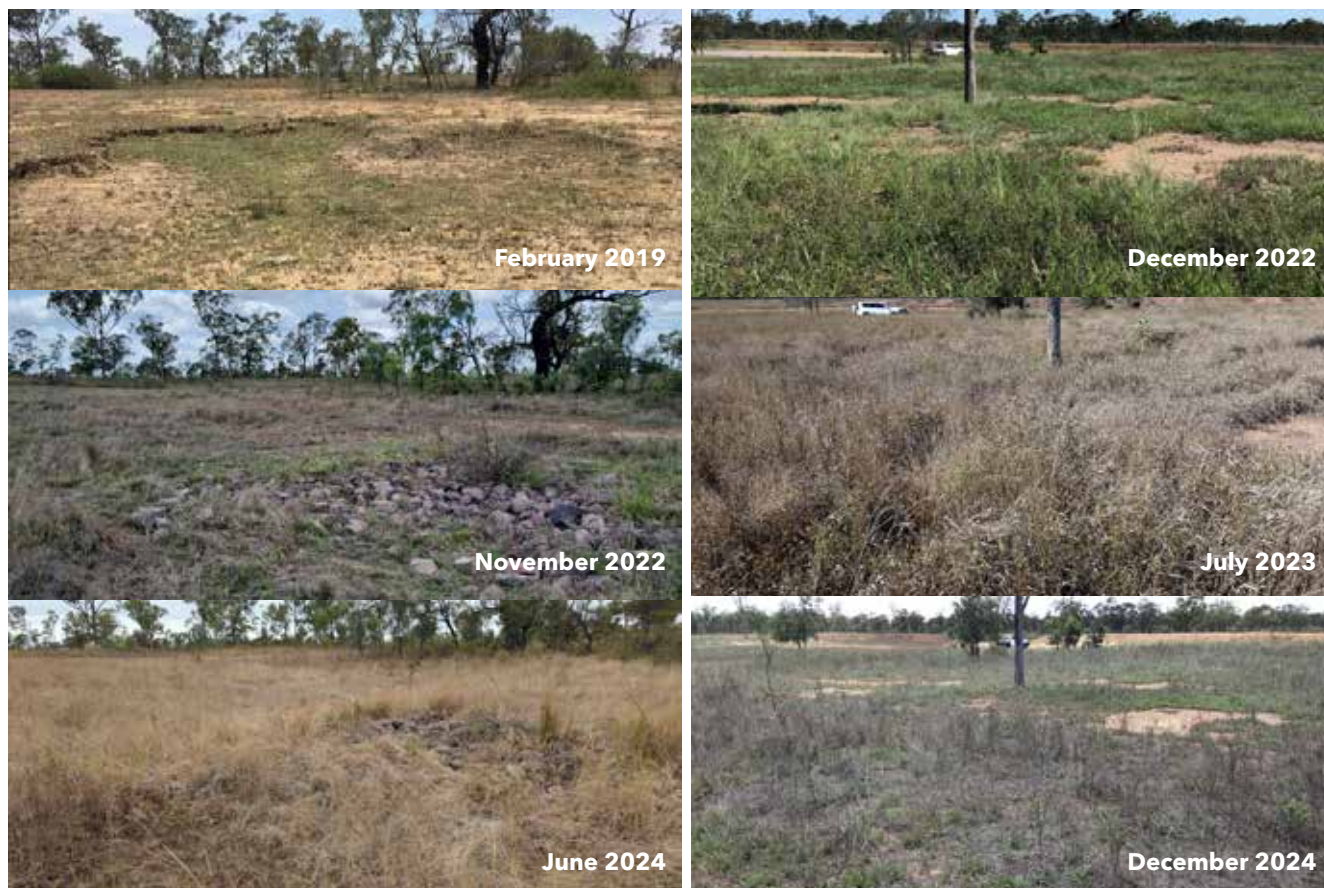
Figure 20. Monitoring point photographs of remediated catchments at Sites 8 and 10. LCAT results for these sites are represented by **this line** and **this line** respectively in Figure 19.

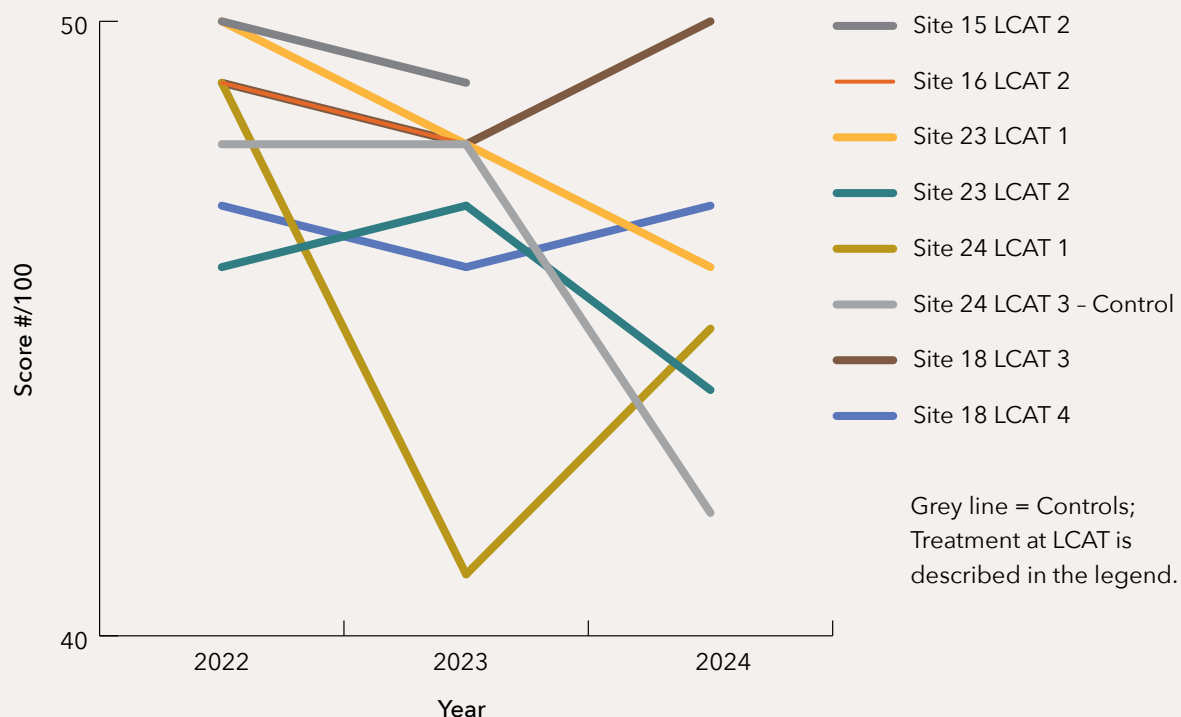
The consistency of the land condition scores for the catchments of the four small-scale gullies in Vertosol (Downs country) soils are shown in Figure 21. The four sites are classified as stable in Figure 18. The consistent scores suggest that the interventions had little effect on land condition, and this reflects field observations over the three years. The treatment at all sites involved installing banks to slow runoff and divert it away from gully heads. Therefore, the intervention did not concentrate on pasture renovation. However, the sites with banks designed to hold water changed the vegetation in the vicinity and while they prevented runoff from entering gully heads, the banks did not appear to improve the land

Figure 21. Land Condition Assessment scores clustered around 45-50 for the catchments of four Small scale gullies in vertosol soils (Downs Country) following erosion remediation work involving banks to manage overland flows into gullies.

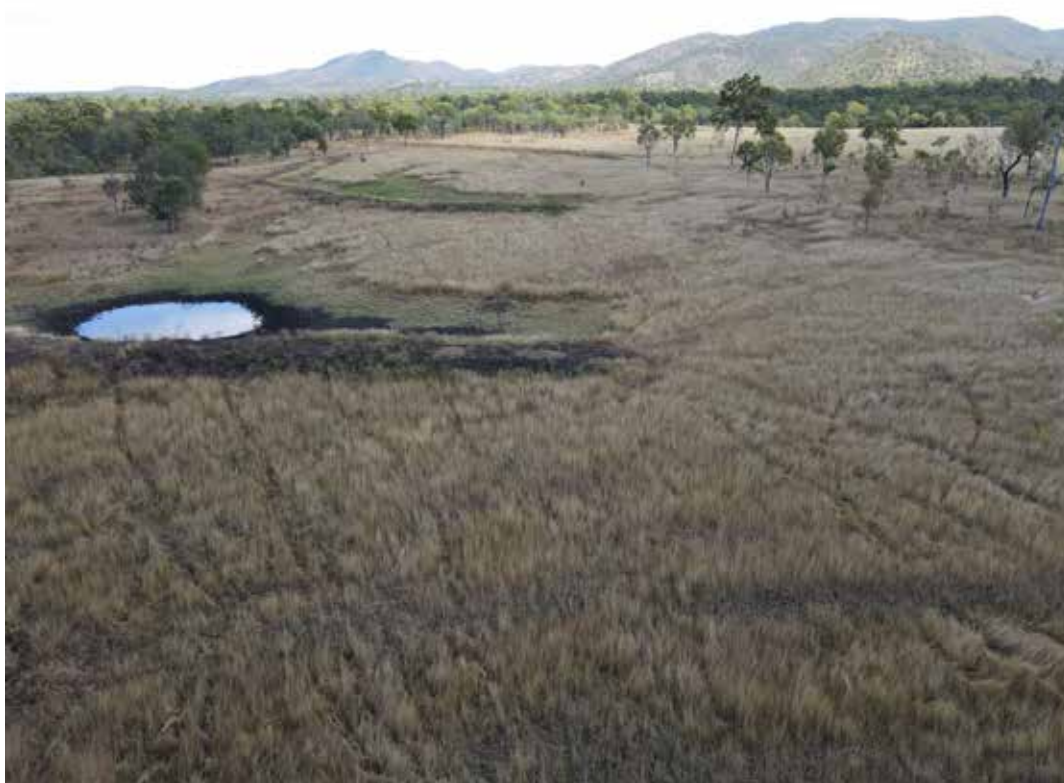
condition at the catchment (Figure 22). At Site 18 the pasture in the wetter zones, behind the banks changed from predominantly Indian couch to couch grass, annual forbs and *Parthenium* weed (*Parthenium hysterophorus*). The pasture at all sites was dominated by Indian couch (*Bothriochloa*

pertusa) before and after the works. Consequently, the ground cover was consistently high, but LCAT scores depressed as Indian couch is considered undesirable.

Figure 22. At Site 18 catchment work to control runoff into adjacent gullies involved a series of ‘rehydration’ banks. Photograph taken April 2024.

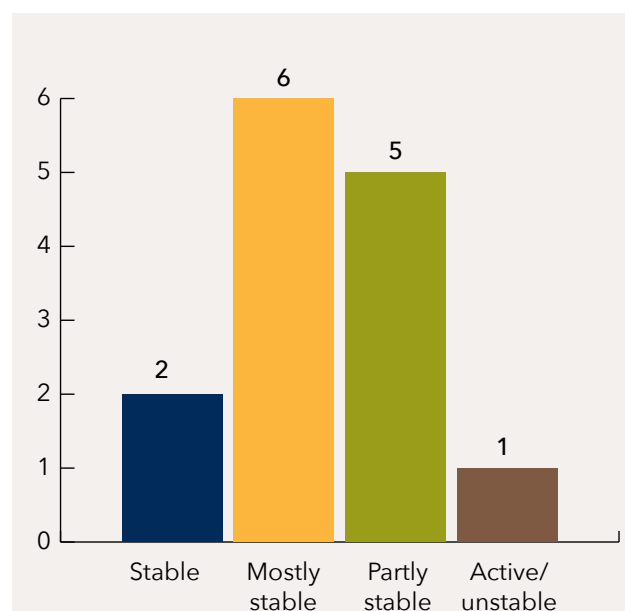
Thirteen of the 14 gullies treated have achieved some level of stability (stable, mostly stable or partly stable) and may be considered to have moved in the desired direction since remediation work was undertaken (refer to Figure 23 and Table 3).

At the unstable gully (Site 22) initial works included reshaping, gypsum, fertiliser, seed, a bund and two rock chutes. Some remediation works were undertaken on the rock chutes prior to this monitoring and maintenance project. This site received more comprehensive maintenance in 2024. Refer to Figure 29 for details. While the initial response following this maintenance is positive, more time is required to see if the site is on a pathway to stabilising.

Four of the partly or mostly stable sites had maintenance works done: Site 13 - landholder in-kind, Sites 9 and 10 received maintenance in 2024 and Site 14 had two lots of maintenance between 2021 and 2024. Site 12 received early

Figure 23. Level of stability achieved at treated small-scale gullies 4-5 years after the initial treatment. Assessed December 2024; sites where only the catchment was treated are excluded.

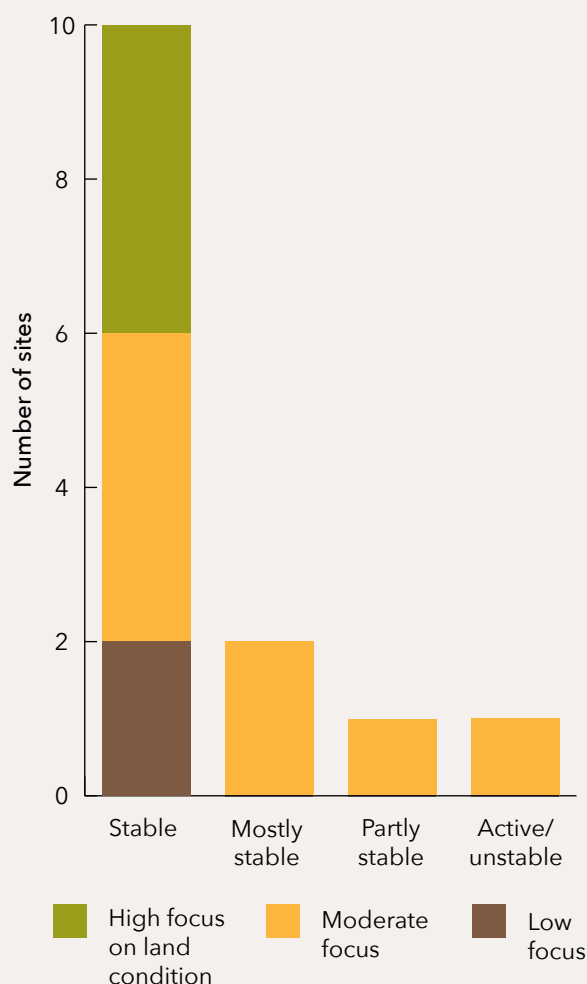
Figure 27. The level of stability achieved at treated catchments of small-scale gully sites versus the landholder's focus on improving land condition (2019/20-2024).

Figure 27 displays the results of stability achieved versus grazing land management for the treated catchments. The two catchment sites deemed to be under management with a low level of focus on land condition achieved stability but were on near-level ground; old floodplain terraces that only had banks installed to attenuate flows into gullies. The remaining 12 sites were on sloped land (above hillslope gullies). Of those that achieved stability, half were managed by graziers who were considered to have a high focus on improving land condition at the site.

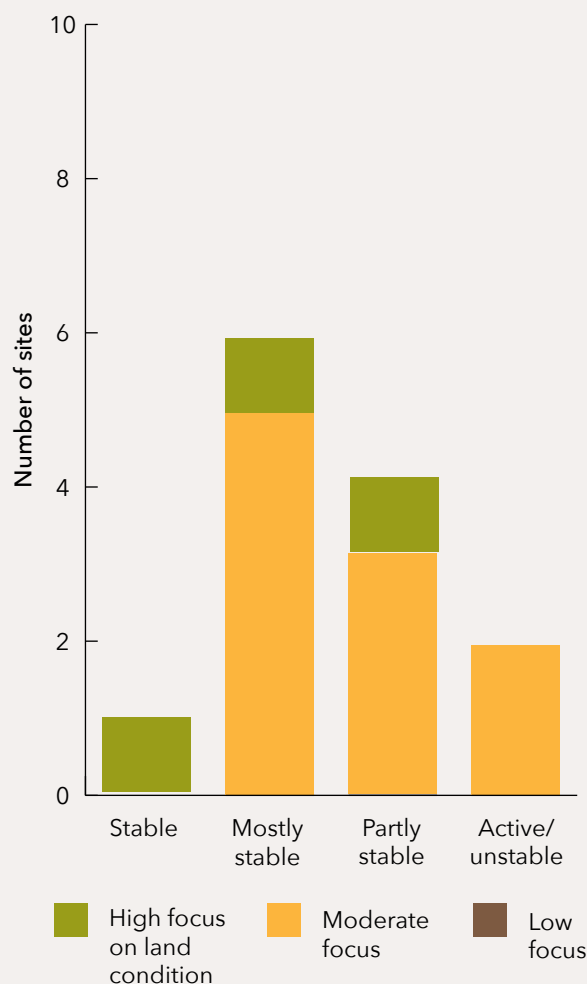
Figure 28. The level of stability achieved at treated gullies of small-scale gully sites versus the landholder's focus on improving land condition (2019/20-2024).

Figure 28 displays the results of stability achieved versus grazing land management for treated gullies. All sites had moderate or high ratings for the landholder's grazing land management expressed as 'Focus on land condition'. Overall sites managed with a high focus on land condition performed better than those with a moderate focus.

One of the unstable sites (Site 22) had high grazing pressure by wallabies which is one of the factors leading to the poor result. Cattle were excluded from the site and the rest of the paddock was stocked lightly (cattle) and rested in the wet season. The one stable site that had a high level of pasture management, was in Downs country Vertosol soil. The eight gullies that received maintenance after construction are found across all categories: in levels of stability and in the landholders' 'Focus on improving land condition'.

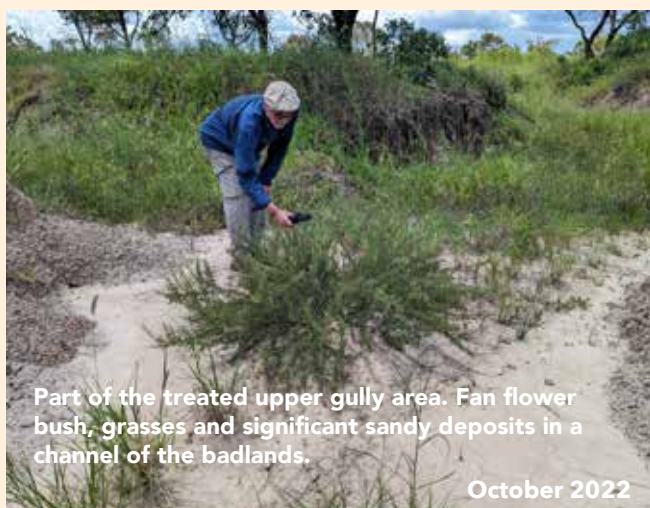
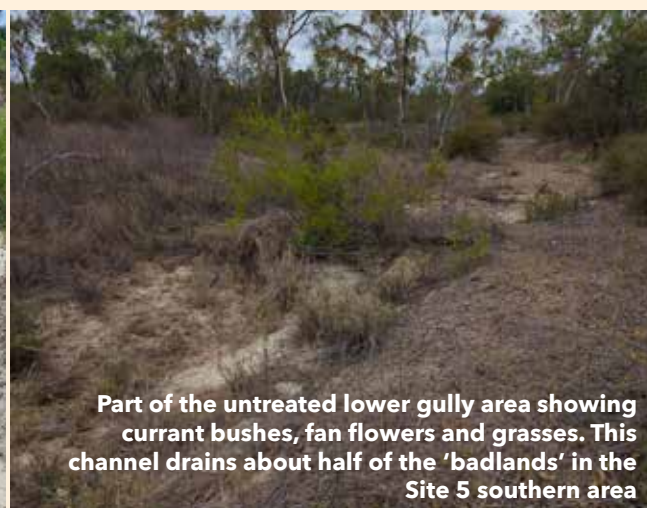
Figure 30. Additional information on the low impact works at Site 5.

Site 5’s low impact remediation works in the upper gully scarps and channels of the ‘badlands’ were relatively successful and should be considered for the remediation of similar sites (Figure 30). It is likely to be a cost-effective and practical alternative on old gully sites where rates of soil loss are diminishing and therefore costs need to be kept relatively low.

Such light approaches focus on facilitating natural regeneration and therefore, it suits for work to be carried out in stages; utilising an adaptive plan, tailored to the site and responding to the progress achieved in previous stages. It is anticipated that if Site 5’s southern section had another one or two stages, it may have been ‘mostly stable’ in five years with a diverse, primarily native, cover of vegetation.

The works in Site 5's southern section were low impact because landforming earthworks were deemed to be uneconomical due to the advanced stage of the erosion, the poor fertility of the remaining soil material and the hostile conditions for vegetation. The plan avoided soil disturbance and concentrated in the upper scarps and channels of the 'badlands' where more subsoil remained. The treatment was tailored to the soil materials' deficiencies, involved ameliorants of gypsum, fertilizer and millmud, seeding (specialist plants- halophytes) and mulching of the channels. Together, with total exclusion from grazing, this treatment has facilitated revegetation, creating a habitat that is favourable to the native woody shrubs, particularly the Spiny fan flower (*Scaevola spinescens*) and Currant bush (*Carissa* sp.). Spiny fan flower is regenerating rapidly, responding to the favourable conditions that were created. These low shrubs act as a living weir in the channels; reducing flow velocity causing soil to drop out of suspension. More plants then flourished in the deposited soil material.
